Protecting flanges onshore

Case Study

Protecting an onshore processing plant from further corrosion

Location	Uithuizen, The Netherlands
Local Environment	Onshore processing plant
Date	December 2015
Condition	Cold weather, icy at times
Total Coatings	204
Substrate Type	Flanges
Duration	18 days

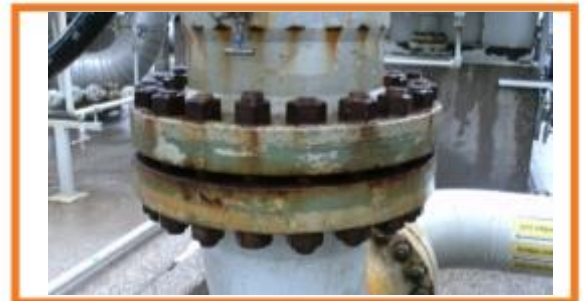
The extent of corrosion can clearly be seen before application

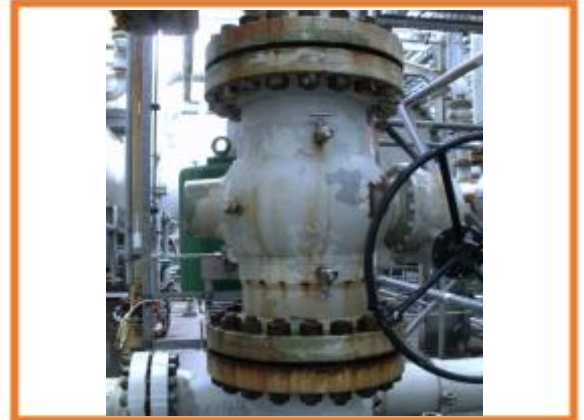
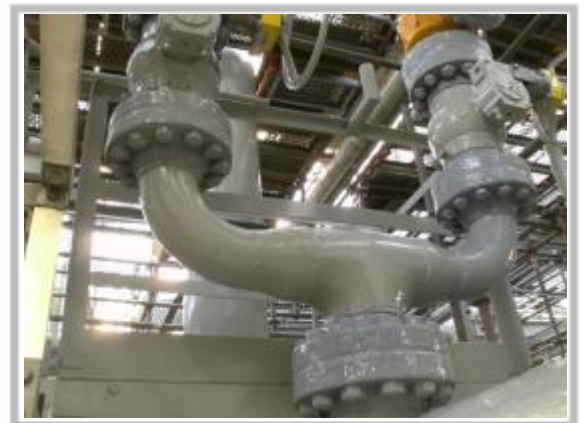
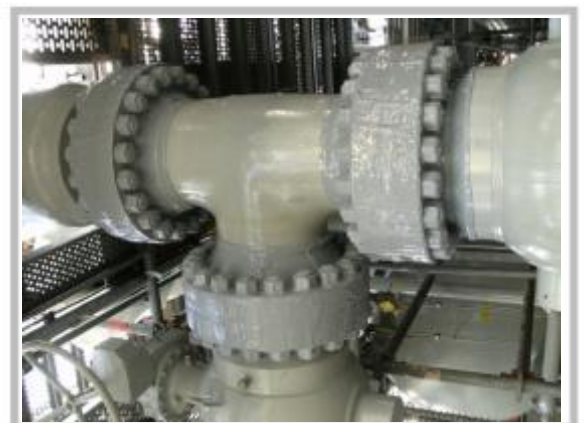
The scope of work was increased to accommodate further corroded assemblies

Whilst working on site, Zero Corrosion recommended that further flanges be protected which showed visible signs of corrosion. This would ensure protection of the equipment and ensure the flanges remained fully operational. These were the additional 42 flanges that were coated over the course of the project, bringing the project total to 204 flanges.
