Case Study:

SF6 Gas Release

<i>Location</i>	Various
<i>Local Environment</i>	Power Sub-stations
<i>Date</i>	2013/2014
<i>Condition</i>	Various
<i>Total Coatings</i>	34 Coatings
<i>Substrate Type</i>	Circuit Breaker Stacks
<i>Duration</i>	Over 7 Day Period

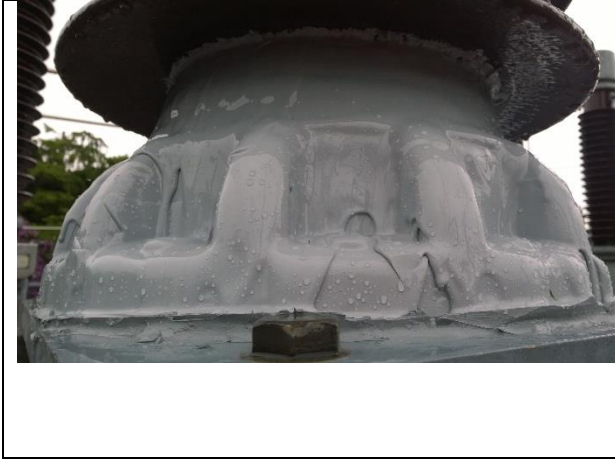
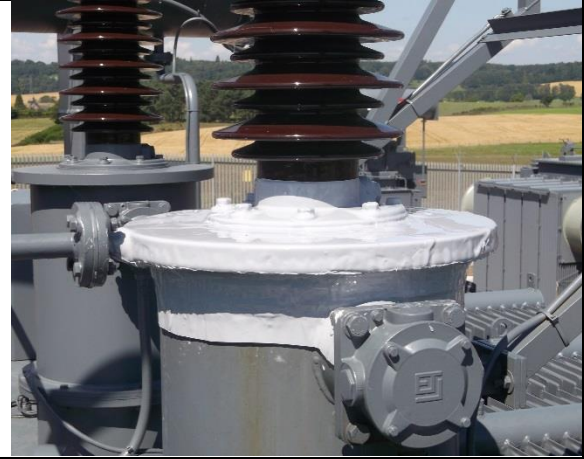
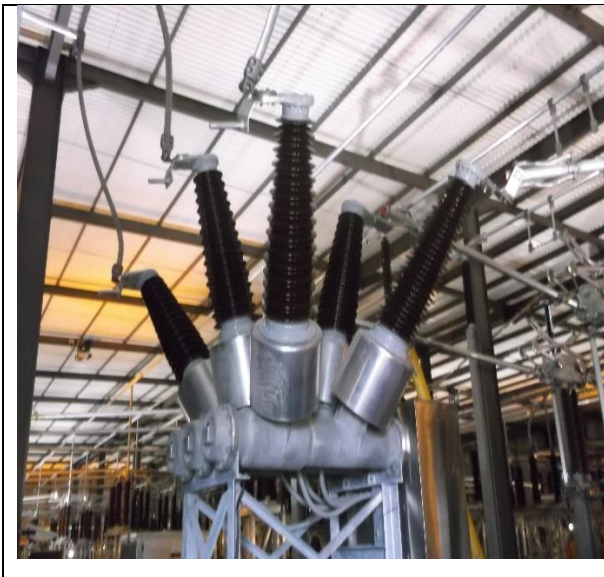
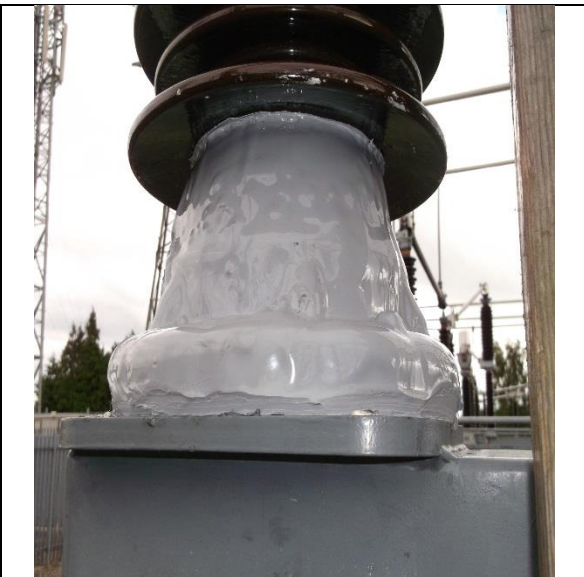
4. Photographs

The first step was to fully understand the nature of the leaks. After years of vulnerability to weather and pollutants, the concrete interface between the joining flanges and aluminium support became porous and had allowed exertion of the contained SF6 gas.

The agreed solution was for Oxifree to firstly apply Oxifree pipe wrap and then to apply two layers of Oxifree TM198 to give an overall thickness of approximately 6mm.

The malleability of applied Oxifree also provides a visual aid should any further leaks occur, by forming a highly visible bubble on the coating. Oxifree will contain low pressure release of the gas, but the use is purely corrosion and degradation protection.
