Protecting flanges onshore

Case Study

Protecting an onshore processing plant from further corrosion

Location	Uithuizen, The Netherlands
Local Environment	Onshore processing plant
Date	December 2015
Condition	Cold weather, icy at times
Total Coatings	204
Substrate Type	Flanges
Duration	18 days

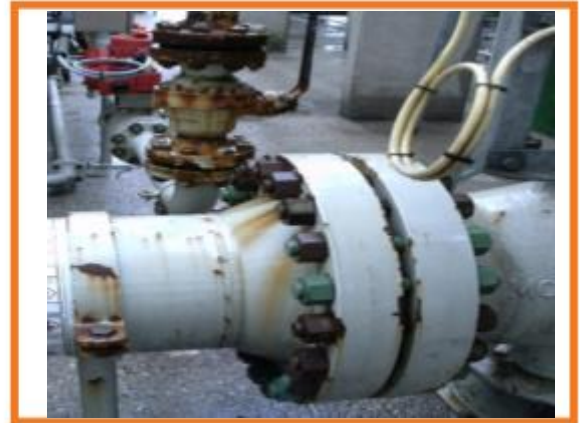
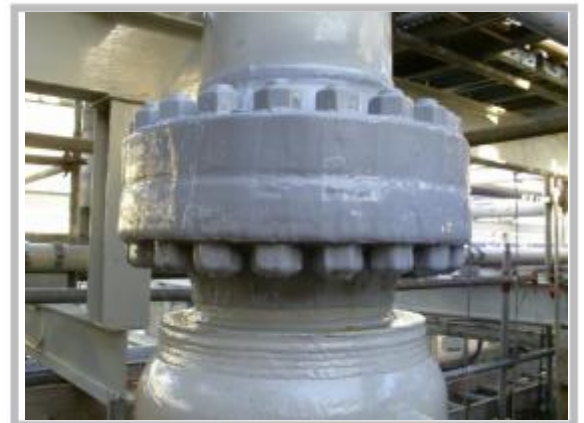
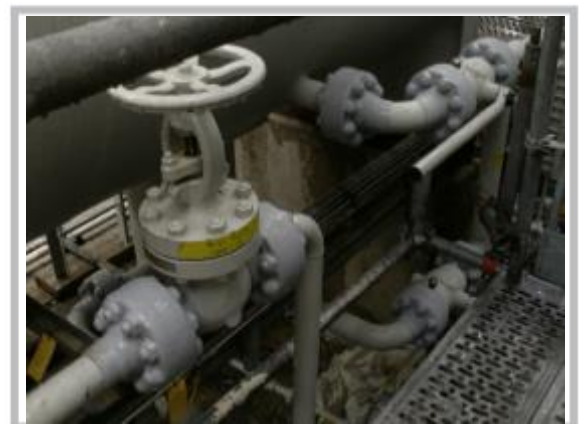
Whilst working on site, Zero Corrosion recommended that further flanges be protected which showed visible signs of corrosion. This would ensure protection of the equipment and ensure the flanges remained fully operational. These were the additional 42 flanges that were coated over the course of the project, bringing the project total to 204 flanges.

The application of TM198 will extend the life of these assets and protect them from harsh environment they are exposed to on the coast. The material can easily be removed for inspection and simply refilled.
